**ASBESTOS SURVEY REPORT**  
**MULTIPLE BUILDINGS**  
**700 ROBBINS STREET**  
**PHILADELPHIA, PA 19111**

***BEA# 772615L***

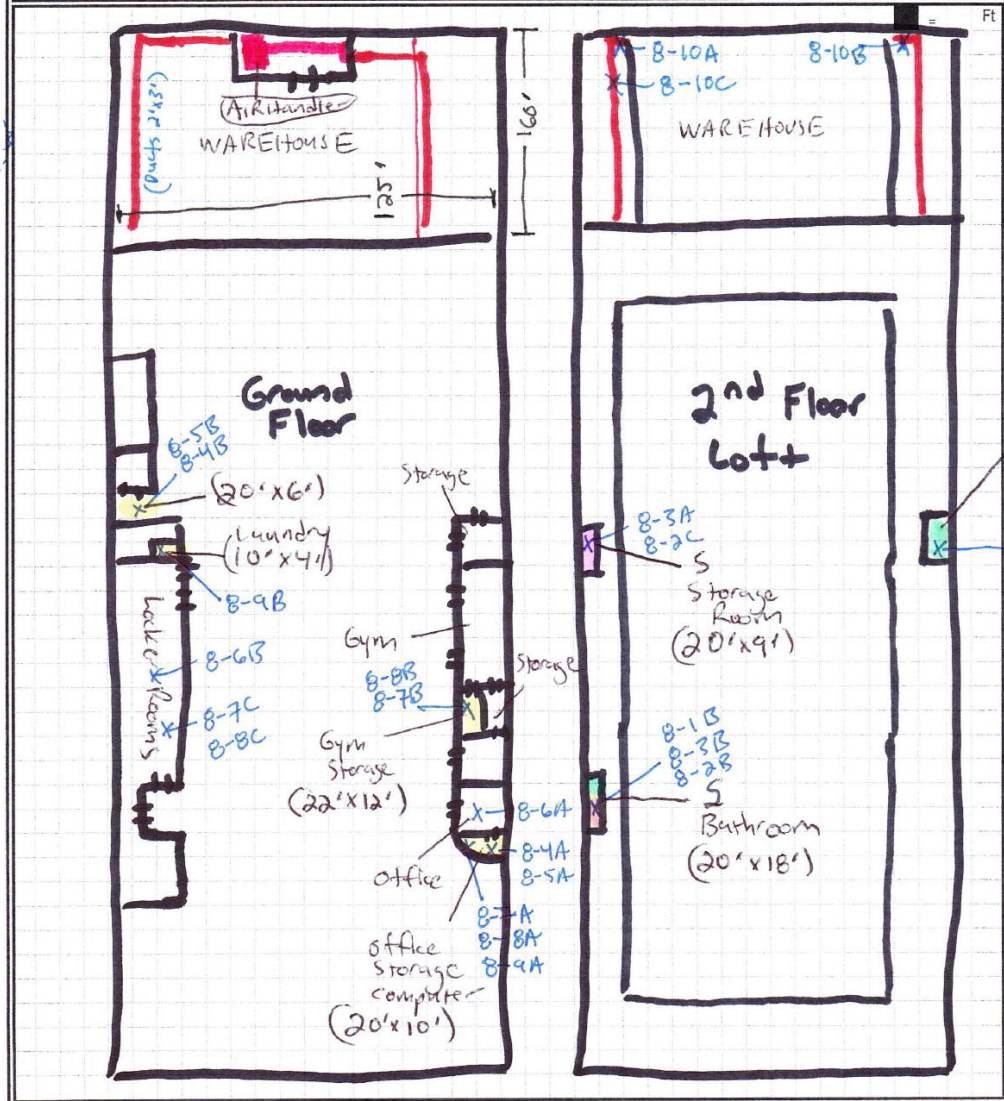
Drawing Sheet 1 of 1

\*10,000 SF  
 of Duct  
 Air Handler  
 Across cell

\* TST Pipe Ins.

\* Duct + Friction  
 Across cell

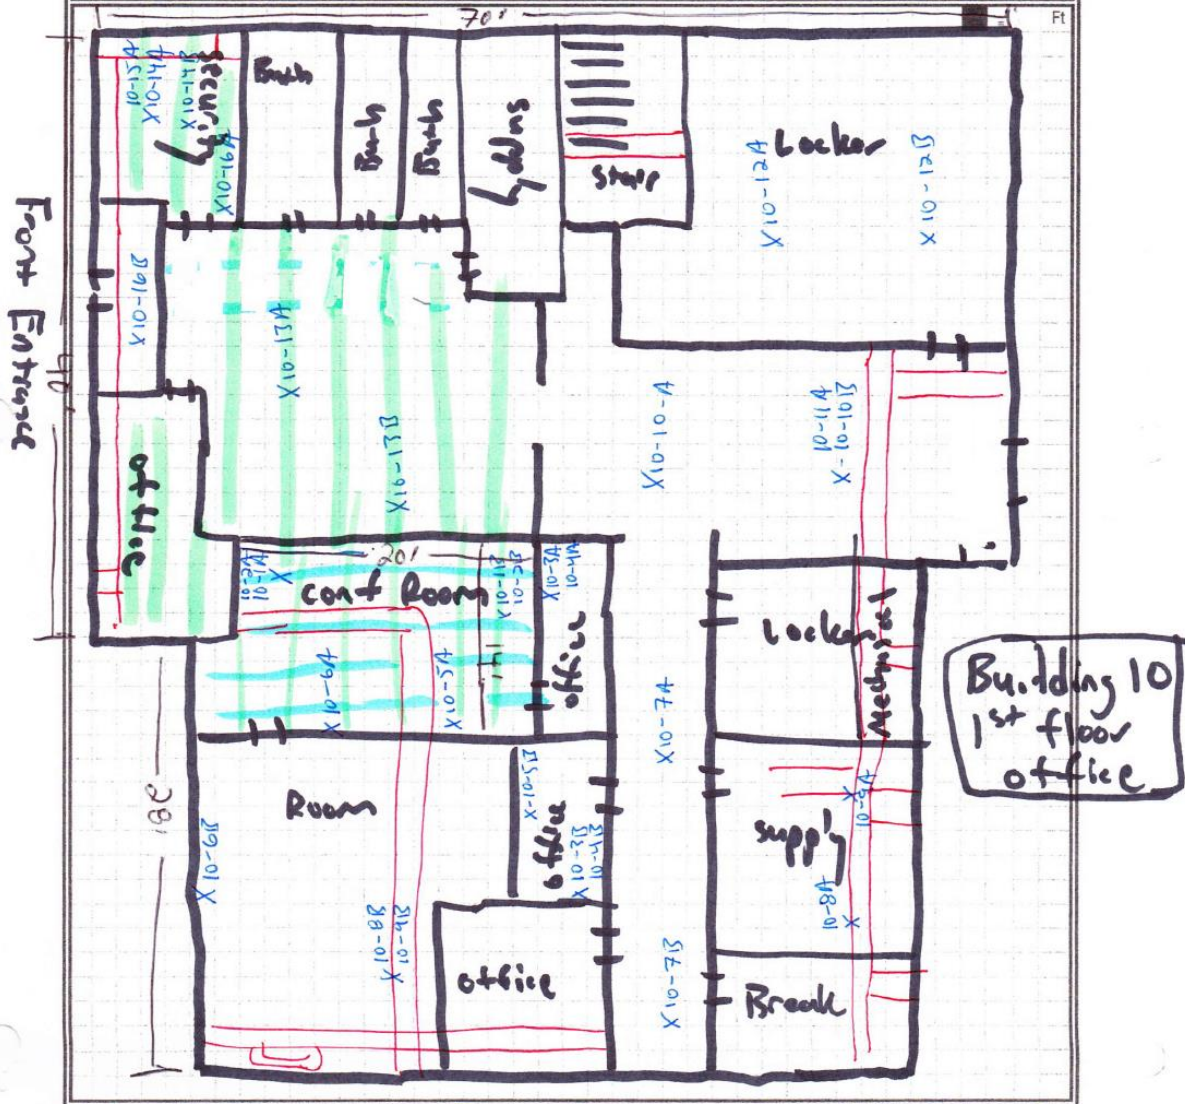
Drawing Sheet 1 of 3

12x12 Floor tile  
9x9 Floor tile

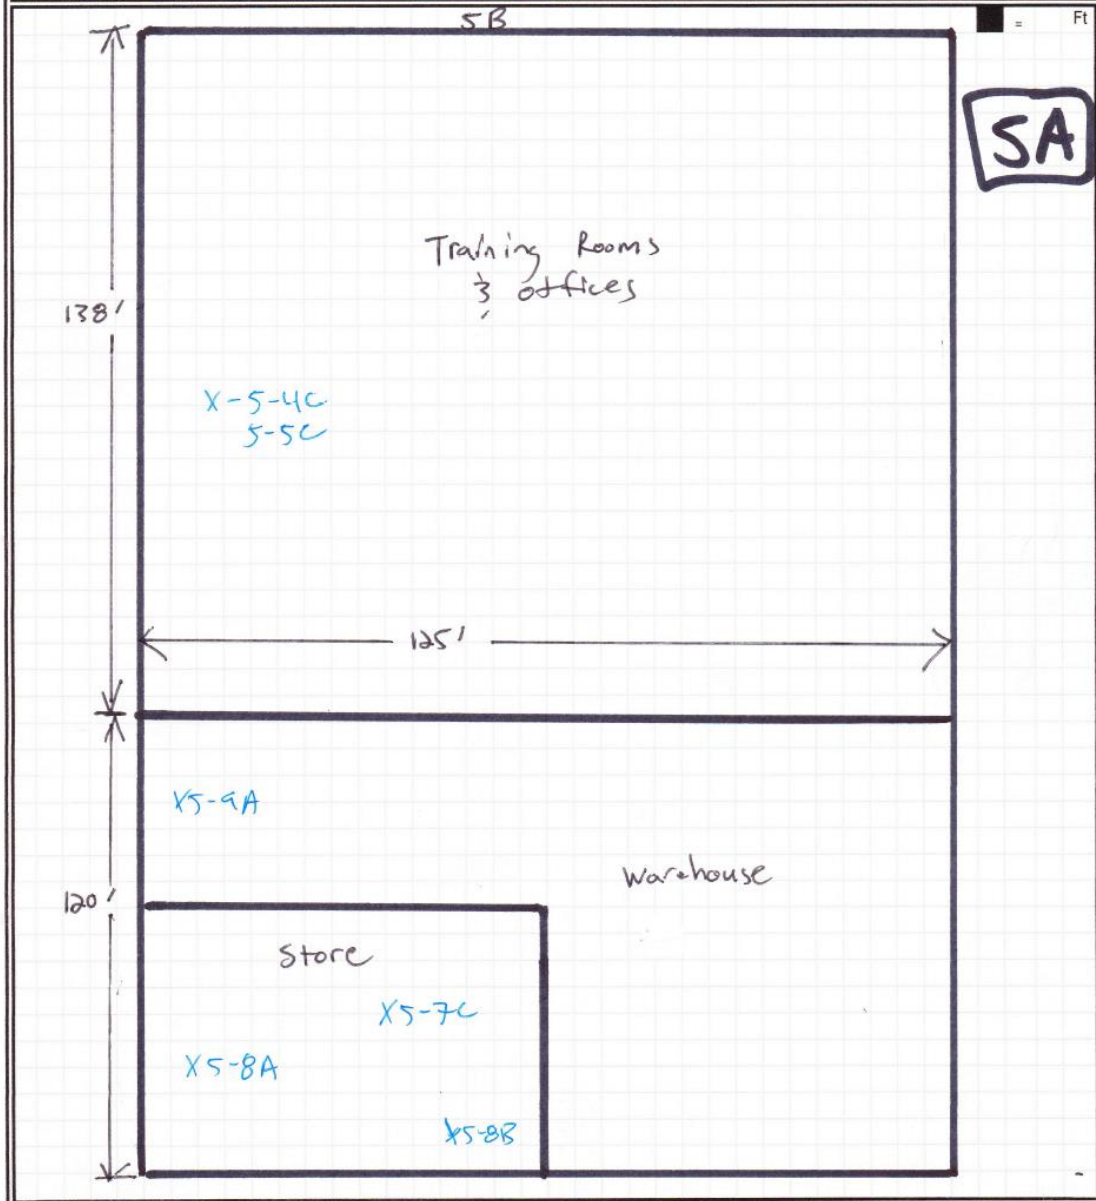
BEA#: 772615L  
Date:      /      /       
Drawing Sheet      of

\* No ACM (TSI) Insulation

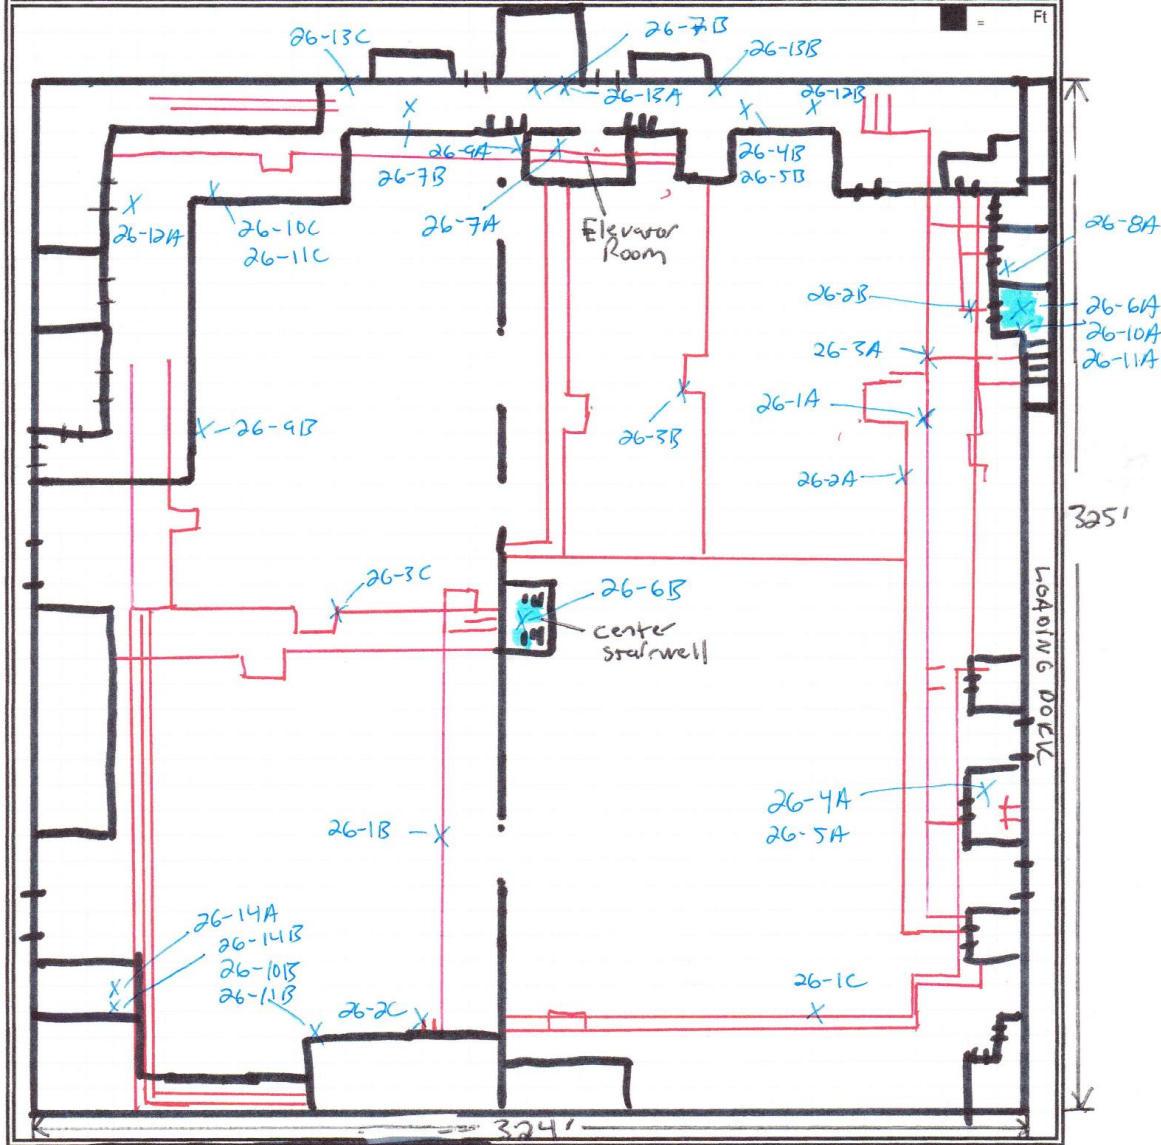
**Building 26 1st Floor**

~~TSE~~ Lines (4cm)  
9x9 Floor tile
